## SPOT INSPECTION SERVICES

## HOME INSPECTION REPORT

5781 Grandview Blvd  
Mound, MN 55364

10/06/2025

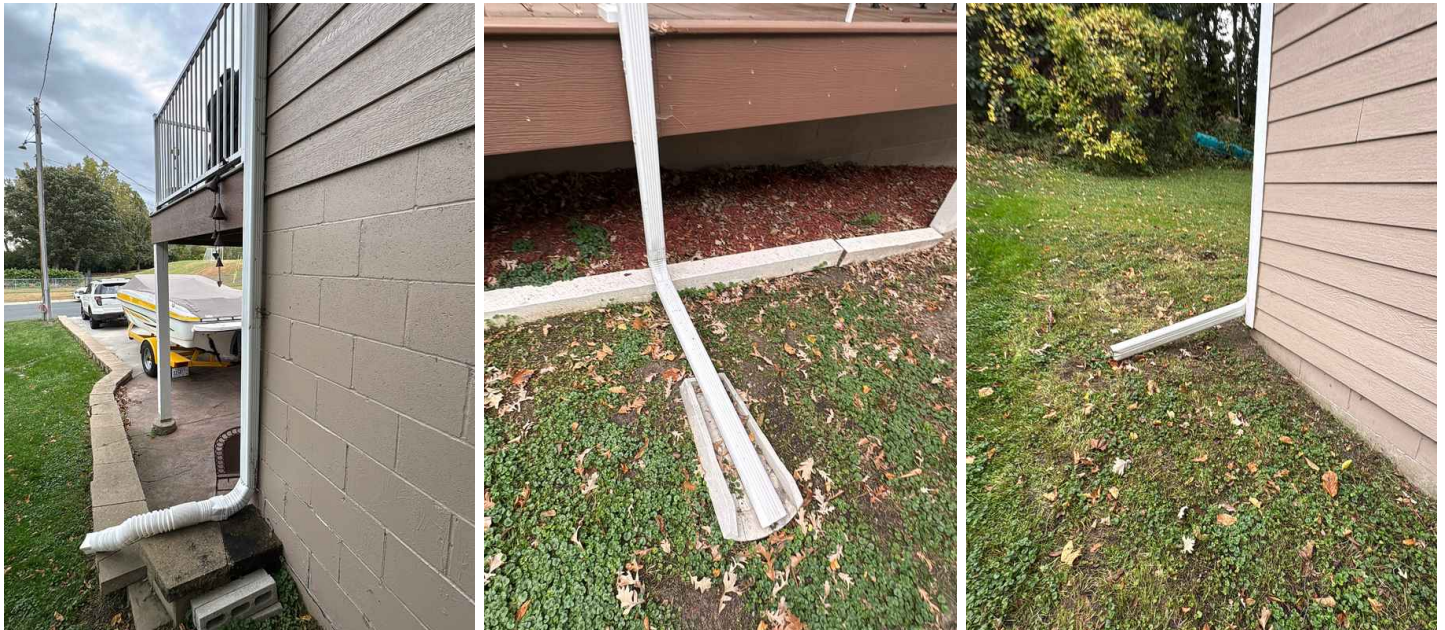
## 2.6.1 Gutters &amp; Downspouts

One or more downspouts drain too close to the home's foundation. This can result in excessive moisture in the soil at the foundation, which can lead to foundation issues and elevated moisture levels in the basement. This can also lead to siding damage near the downspout. Recommend adding downspout extensions to get water as far away from the foundation as possible.

Contact a qualified gutter contractor

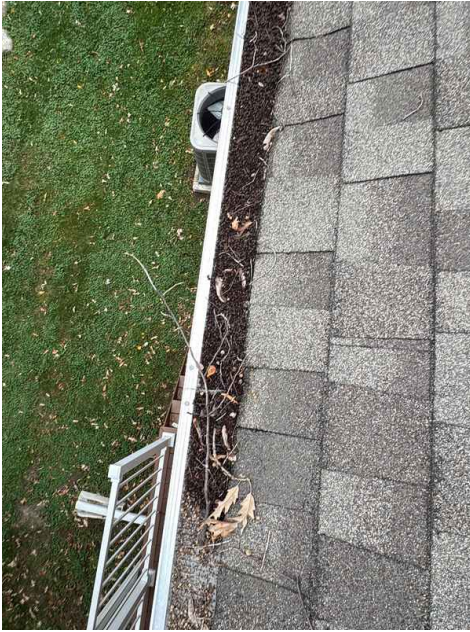
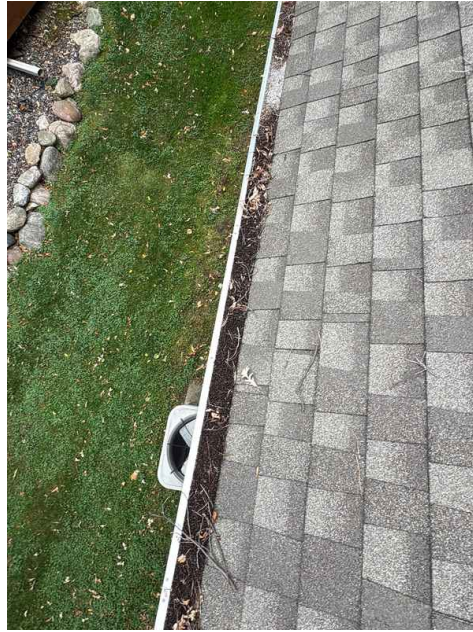
## 2.6.2 Gutters &amp; Downspouts

I observed debris in the gutter. Cleaning and maintenance is recommended. Consider adding a gutter guard product to gutters.

Contact a qualified gutter contractor

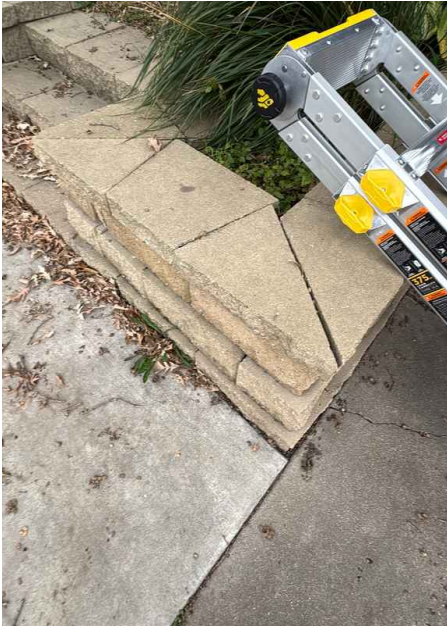
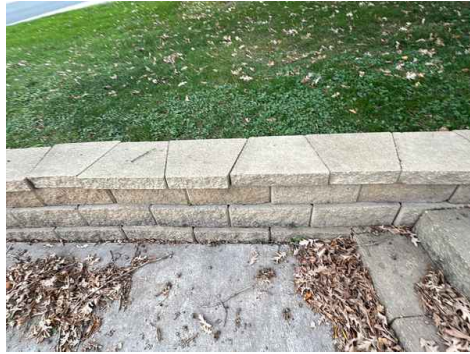
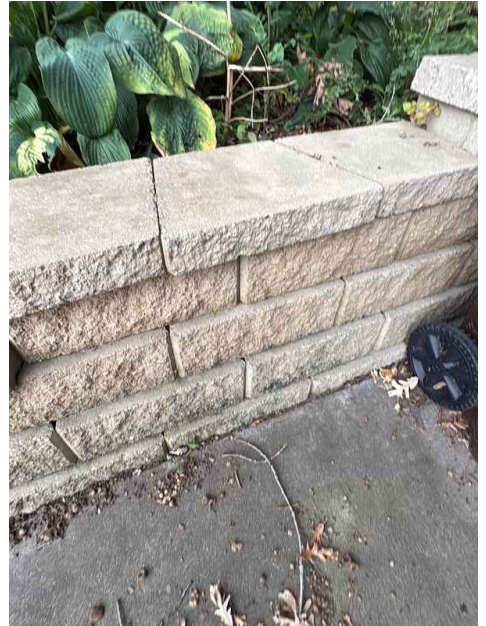
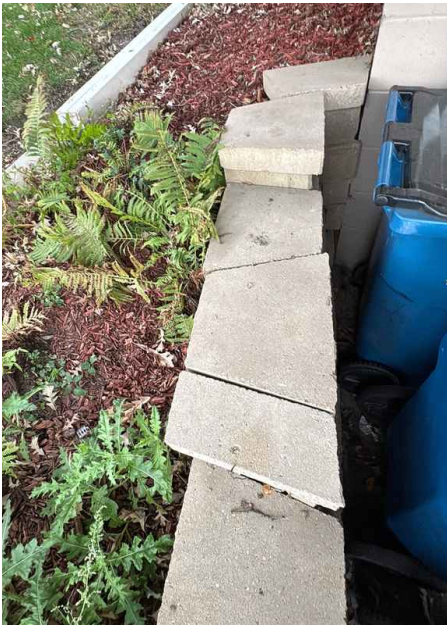
## Retaining walls : Retaining Walls Inspected

I checked any retaining walls for signs of leaning, cracks, and other damage.

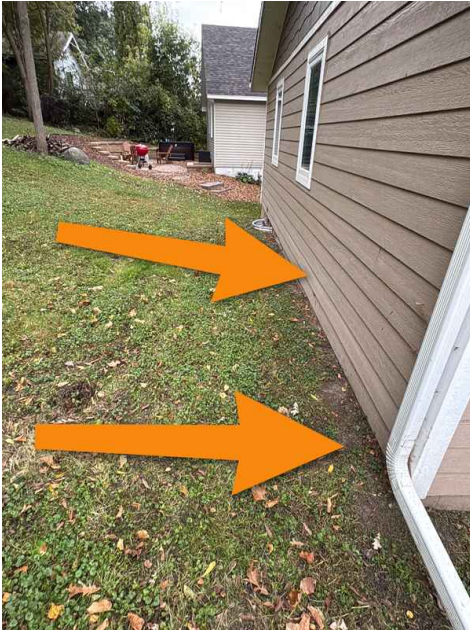
Grading is sloping towards the home in some areas or is very flat. This could lead to water intrusion and foundation issues. This is very common on older homes and especially in the city where space is limited. Ideally, the ground around a house should slope away from all sides, ideally 6 inches for the first 10 feet from the house foundation perimeter. This isn't always possible in a city setting. Making sure that gutters are properly functioning and discharging water away from the foundation is important.

Contact a qualified landscaping contractor

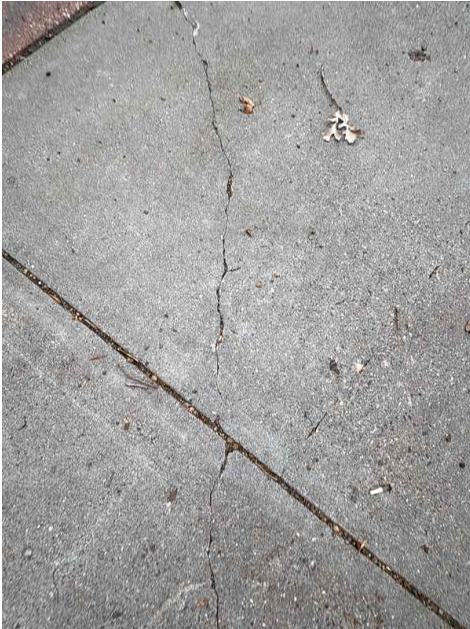
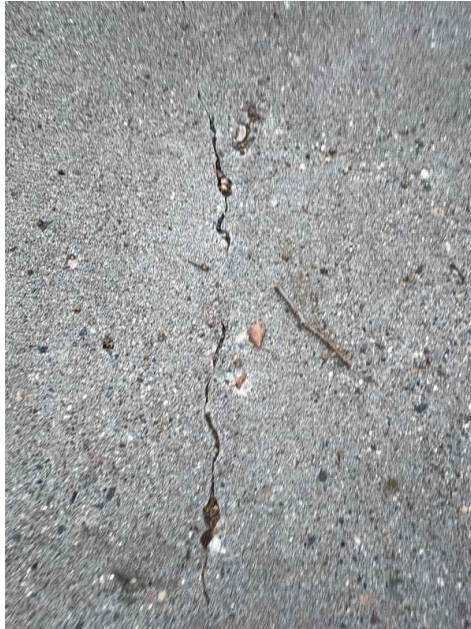
### 3.6.1 Walkways & Driveways

There are cracks present at a concrete walkway or driveway. Cracks can worsen over time. Filling larger cracks can help extend the life of the concrete. Recommend repair or replacement if desired.

Contact a qualified professional.

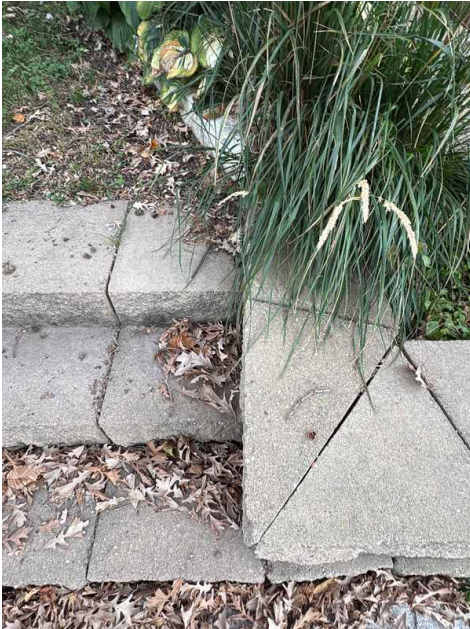
### 3.7.1 Stairs, Steps, Stoops, Stairways & Ramps

I observed a missing graspable handrail at the exterior steps. a handrail would be an added safety measure.

Contact a qualified professional.

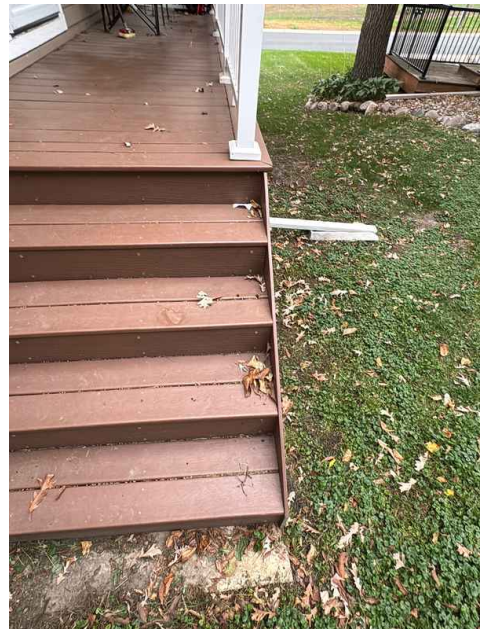
### 3.8.1 Porches, Patios, Decks & Balconies

I observed a missing handrail. There is more than three step here, and I recommend installing a handrail for safety.

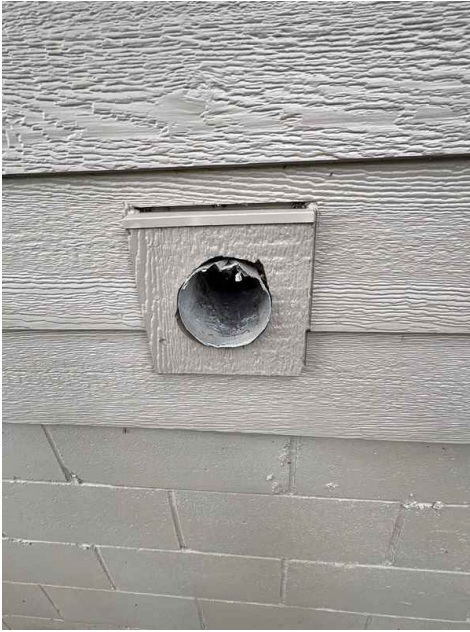
### 3.12.1 Exhaust Hoods

I observed an exhaust hood that was missing on the dryer vent.

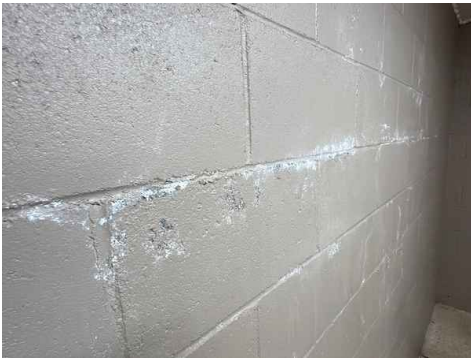
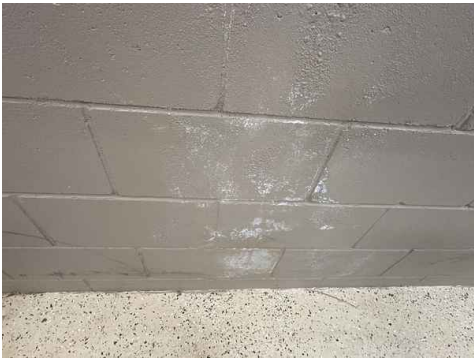
4.5.1 Ceiling, Walls & Firewalls in Garage

MOISTURE INTRUSION

Garage walls showed signs of moisture intrusion. Recommend a qualified contractor evaluate and find source of moisture to prevent further damage and/or mold. Active roof leaks visible in garage sheathing. Roof above garage is old and due for replacement. Recommend further evaluation by a roofer.

Contact a qualified roofing professional.

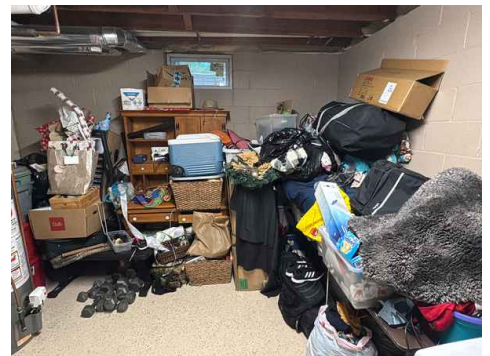
### PERSONAL STORAGE RESTRICTION

Personal items limited my visual inspection. Moving personal items and storage is not required by the Standards of Practice. I could not see everything. Many things were blocking my inspection.

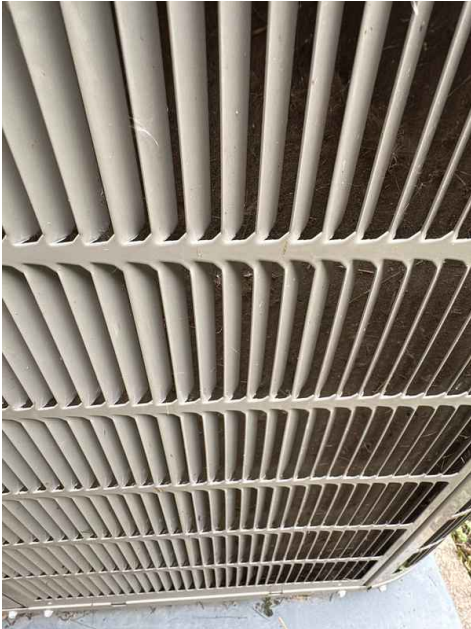
7.1.1 Cooling System Information

I observed that the air flow to the air conditioner unit was restricted because of dirt and debris. This may result in inefficient operation. Cleaning recommended.

Recommended DIY Project

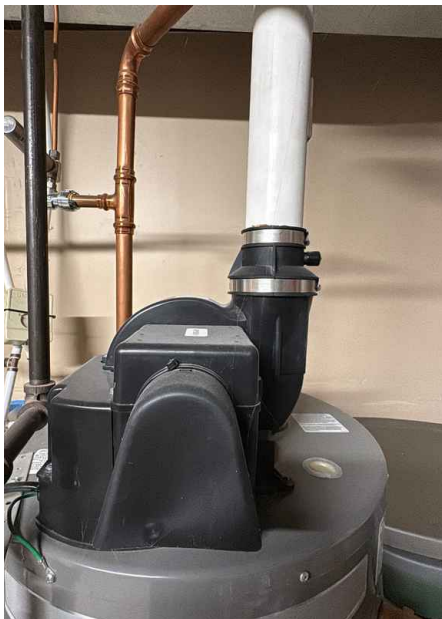
### Hot Water Source: Inspected Venting Connections

I inspected the venting connections.

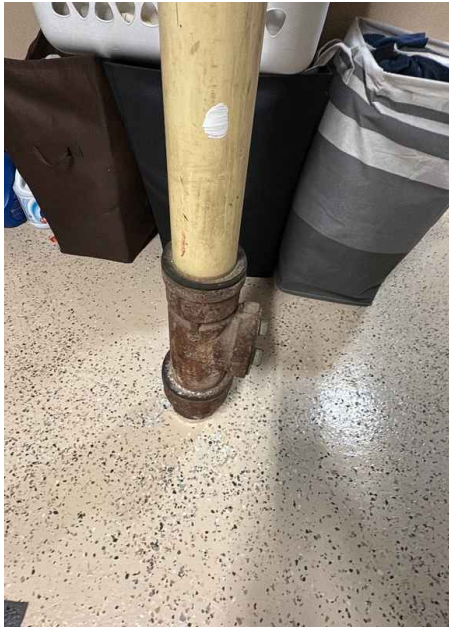
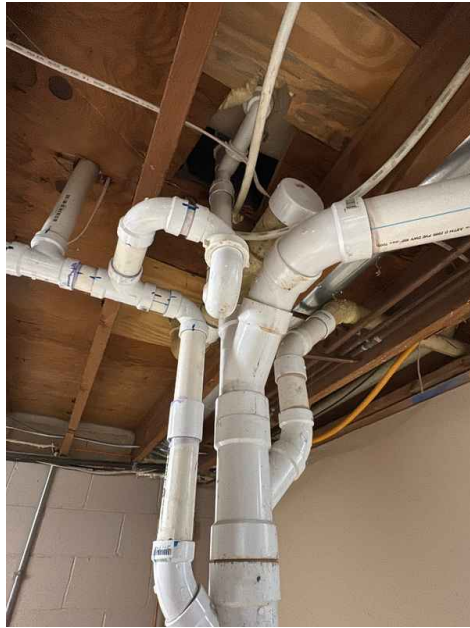
### Drain, Waste, & Vent Systems: Inspected Drain, Waste, Vent Pipes

I attempted to inspect the drain, waste, and vent pipes. Not all of the pipes and components were accessible and observed, this is an inspection restriction. I run water at all house fixtures during the home inspection in an attempt to discover leaks. It's important to note that leaks may not be detectable at the time of inspection but may show up under heavier use scenarios once the house is occupied.

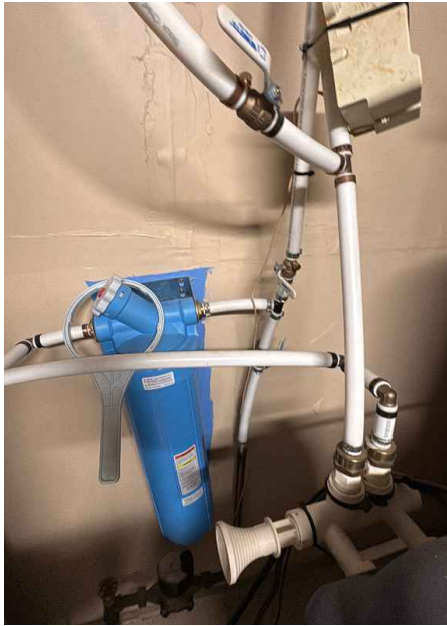
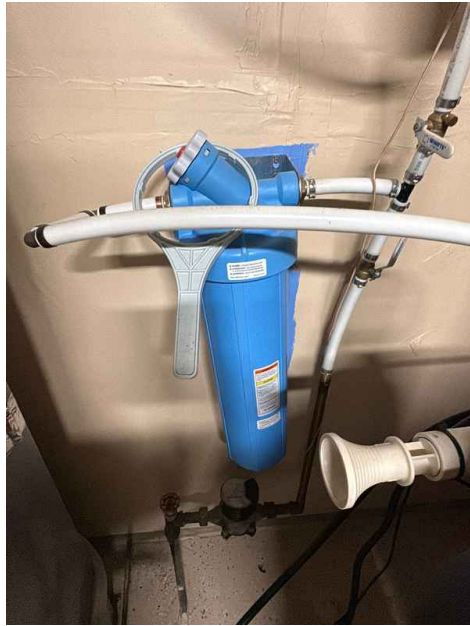
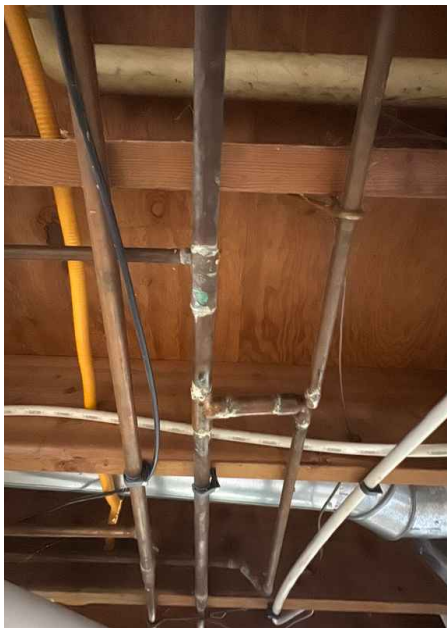
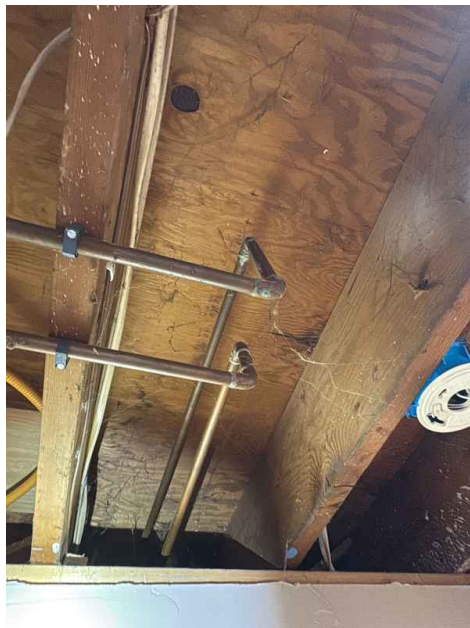
## Water Supply & Distribution Systems: Inspected Water Supply & Distribution Pipes

I attempted to inspect the water supply and distribution pipes (plumbing pipes). Not all of the pipes and components were accessible and observed. Ask the homeowner about water supply, problems with water pressure, and water leaks in the past.

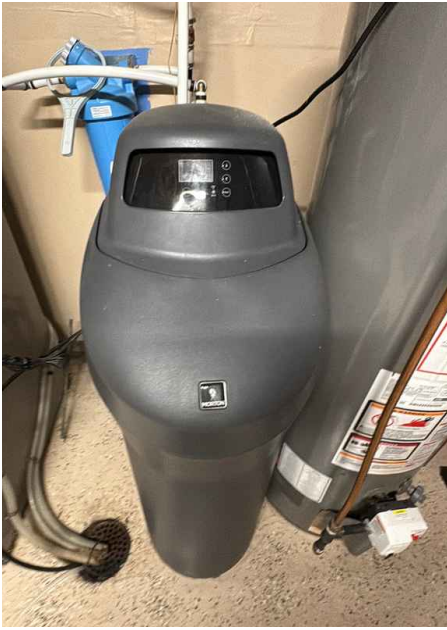
## Water Supply & Distribution Systems: Water Softener

I observed a water softener at the property. Water softeners are outside of the scope of a regular home inspections so the unit was not fully assessed. Ask sellers for more information.

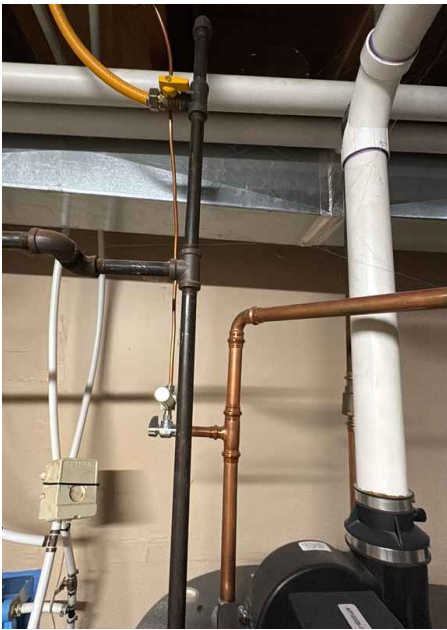
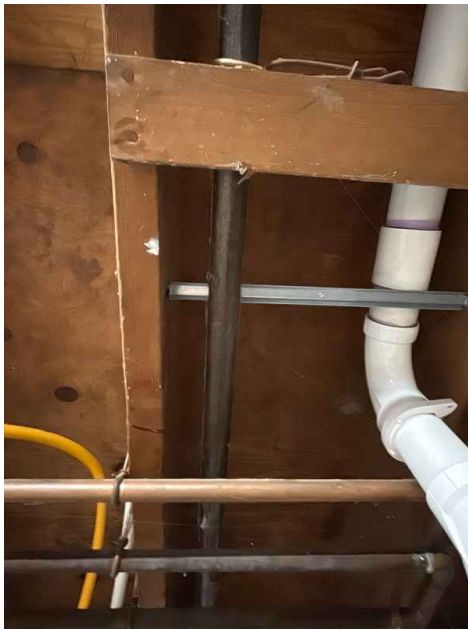
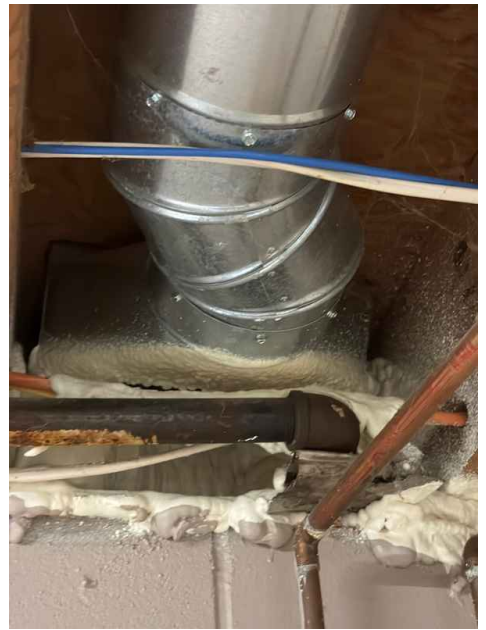
## Gas lines : Gas Lines

I checked gas lines for signs of damage, improper installation, or potential leaks. This is a visual inspection only. For a full safety check of gas lines and combustion appliances contact either your local gas utility or a qualified contractor.

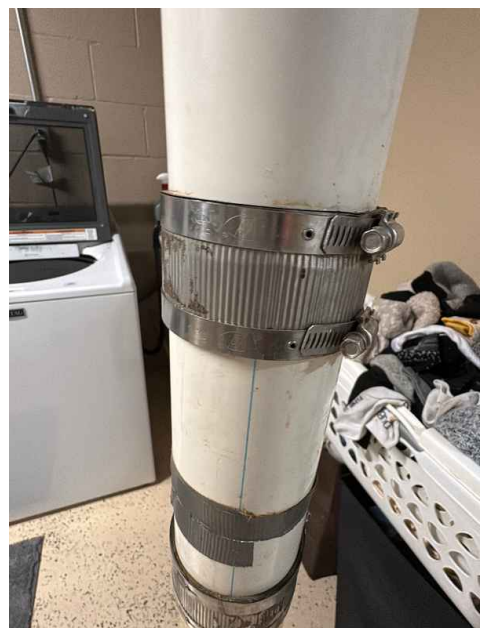
### **IMPROPER PATCHES**

There are signs of improper patching on some drain lines. While these patches may be working, they are not a proper plumbing repair, recommended monitoring for active leaks or properly repairing by a plumber. There were no signs of active leaks at the time of the inspection.

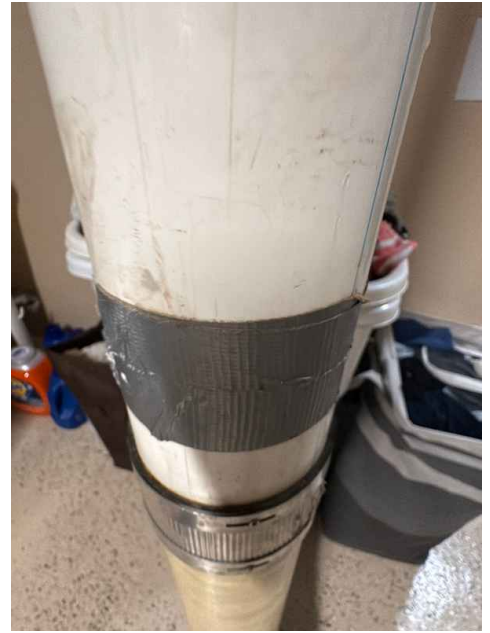
#### 8.4.2 Drain, Waste, & Vent Systems

A waste pipe in the basement was taped or wrapped. This may be signs of a “repair” of a leaking pipe. I did not observe the pipe leaking at the home inspection, however it may leak under heavier use. Recommend monitoring for active leaks and repairing if needed.

Contact a qualified plumbing contractor.

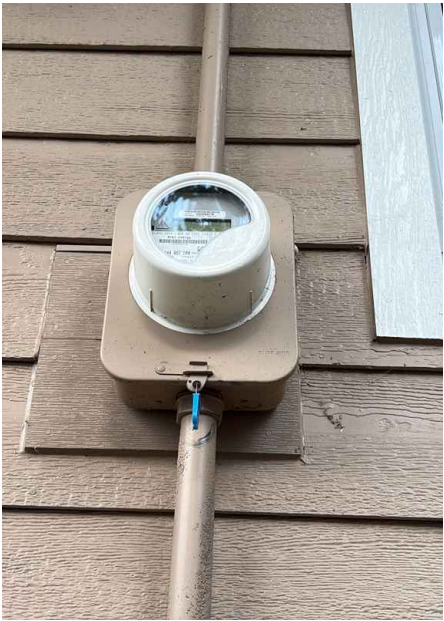
Electric Meter & Base: Inspected  
The Electric Meter & Base

I inspected the electrical electric meter and base.

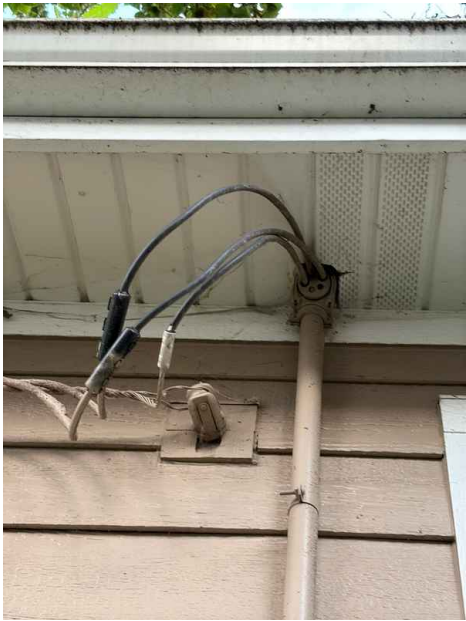
Service-Entrance Conductors:  
Inspected Service-Entrance  
Conductors

I inspected the electrical service-entrance conductors.

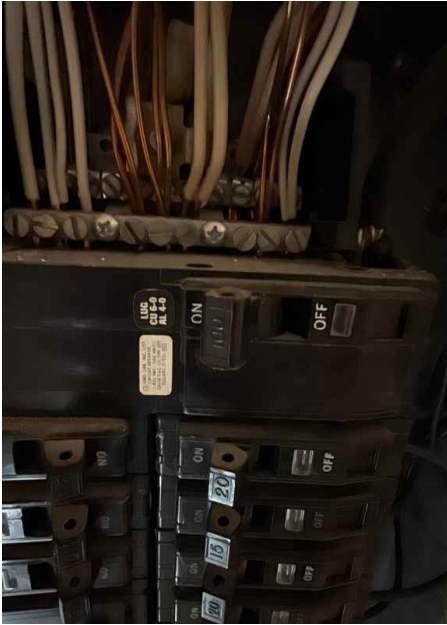
I observed indications of the main service disconnect's amperage rating. It was labeled. I described the service amperage as labeled at the main panel.

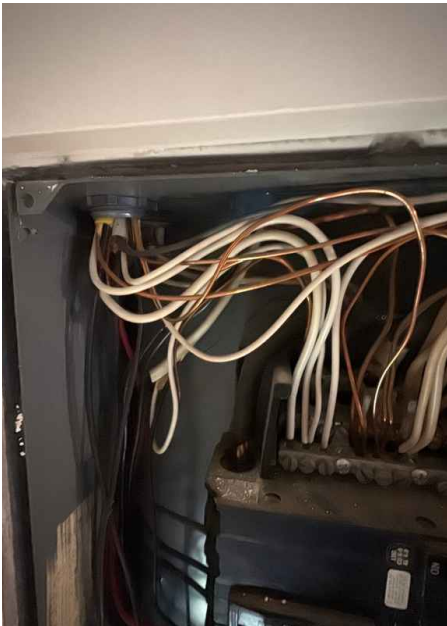
**Electrical Wiring: Type Of Wiring, If Visible**

NM-B (Romex)

I attempted to visually identify the type of electrical wiring in the house. Keep in mind that large portions of electrical wiring in your home is behind walls and ceiling and is not visible. It's not uncommon for older homes to contain old types of wiring (knob and tube, solid aluminum) that may not be readily visible during a home inspection.

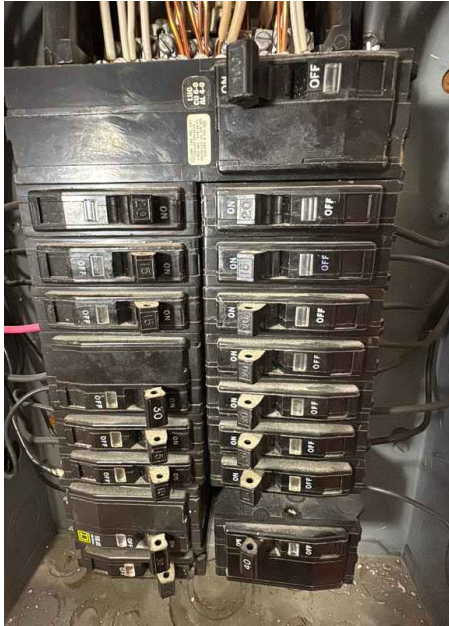
## Panelboards & Breakers: Inspected Main Panelboard & Breakers

I inspected the electrical panelboards and over-current protection devices (circuit breakers and fuses).

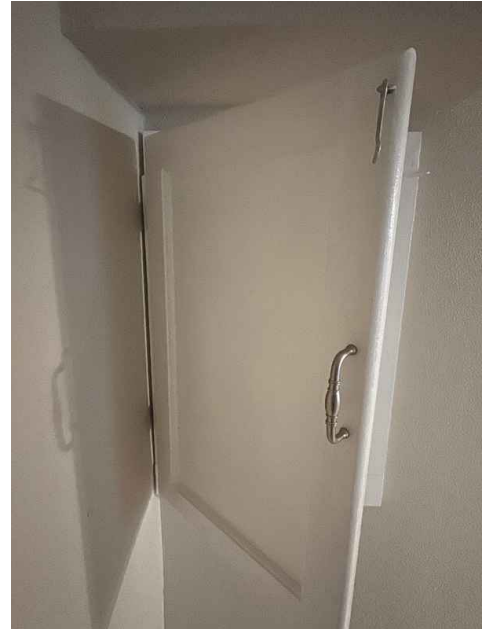
I observed inadequate workspace at the panelboard. A clear working space for accessing all of the electrical equipment is needed. A clear space that is 3 feet deep, 30 inches wide, and 6' 6" in height should be provided in front of the equipment. I was unable to fully remove the front cover to inspect the panel.

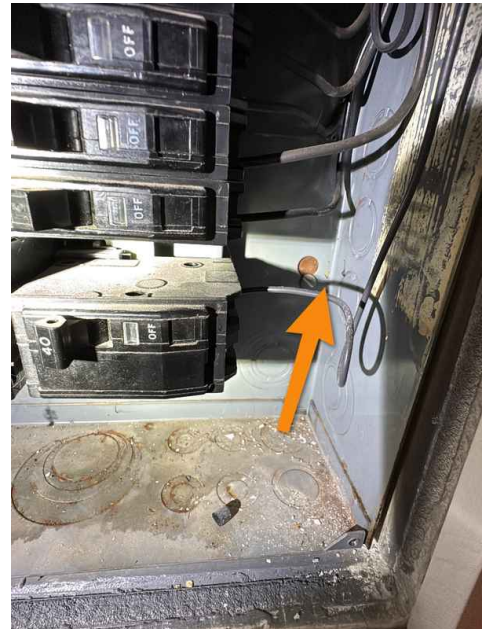
### 9.5.2 Panelboards & Breakers

The wire gauge on the lower right 40 amp circuit looks to be undersized for the amount of power going through and it should be upgraded to avoid possible fire hazard issues.

Contact a qualified professional.

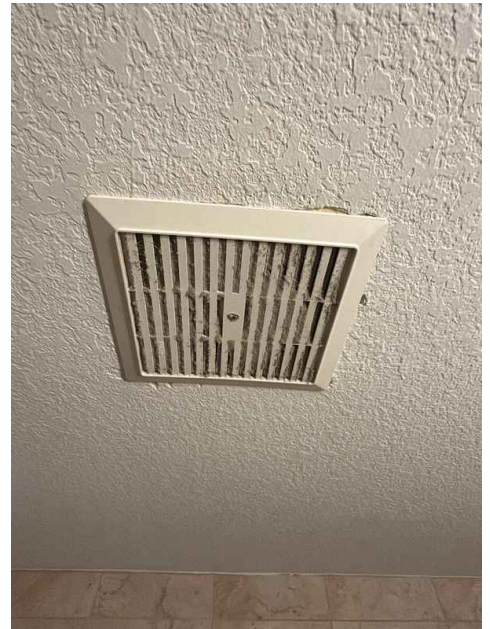
i was unable to confirm that the bathroom fan was properly exhausting. I could not locate a dedicated exhaust hood in the roof or exterior wall that would belong to this vent. Bathroom exhaust fans should vent directly to the exterior of the home. It's possible that this fan vents in the attic space and is covered with insulation. Further evaluation and correction recommended.

Contact a qualified HVAC professional.

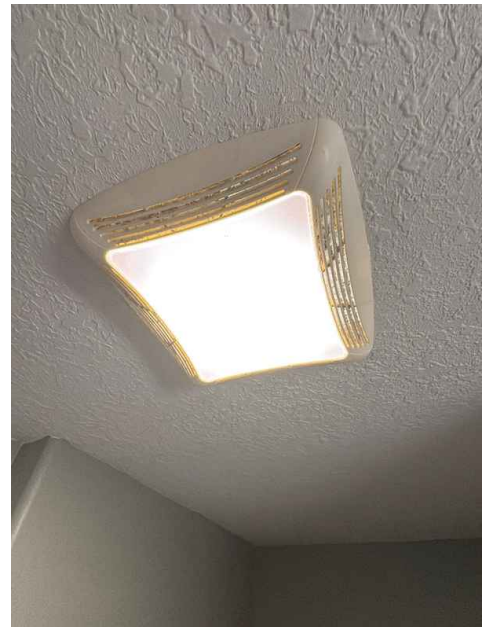
#### 12.5.2 Bathroom Exhaust Fan / Window

##### **BATH FAN DID NOT TURN ON**

I observed that the bathroom exhaust fan did not turn on as expected. Further evaluation and repair or replacement recommended.

Contact a qualified HVAC professional.

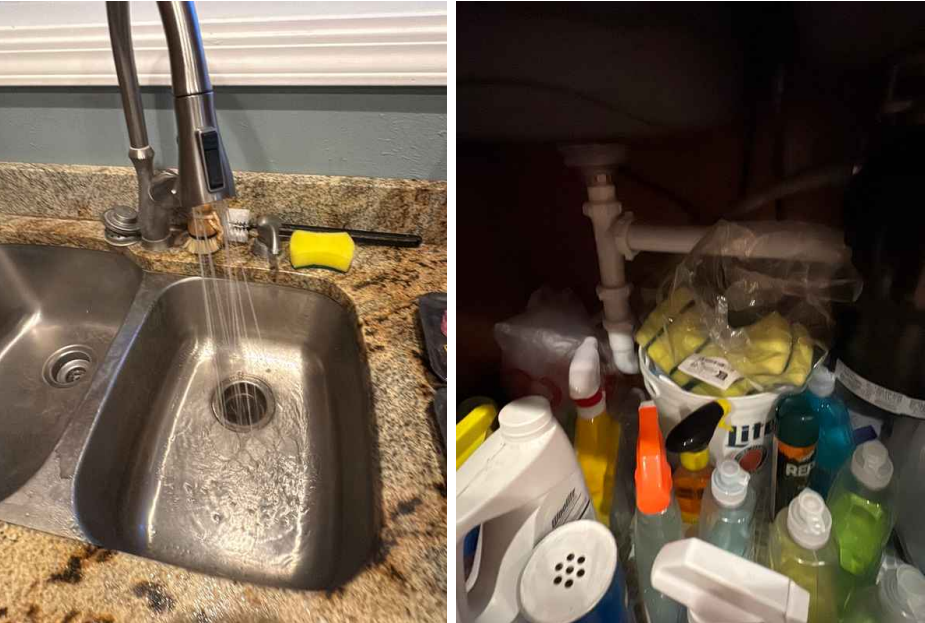
Kitchen Sink: Ran Water At Kitchen Sink

I ran water at the kitchen sink to check for functionality and leaks. It's important to note that leaks may not be visible at the time of the inspection but may show up under more regular/heavy use.

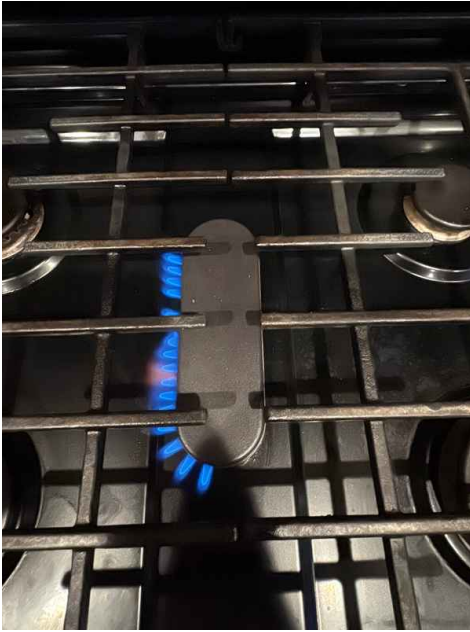
13.6.1 Range/Oven/Cooktop  
**BURNER NOT WORKING**

I observed that one or more heating elements did not heat up when turned on.

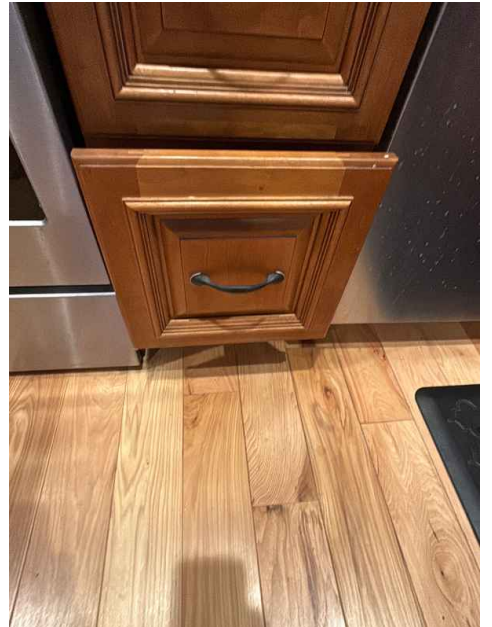
#### **DAMAGED CABINET**

I observed damage at the kitchen cabinet.

Recommendation

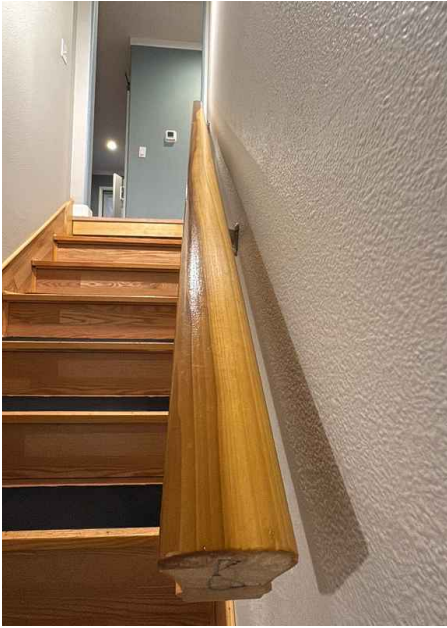
## Railings, Guards & Handrails: Railings, Guards & Handrails Were Inspected

I inspected a representative number railings, guards and handrails that were within the scope of the home inspection.

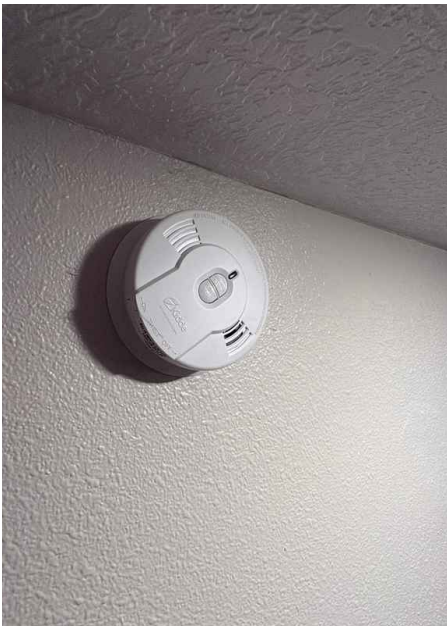
## Presence of Smoke and CO Detectors: Inspected for Presence of Smoke and CO Detectors

I inspected for the presence of smoke and carbon-monoxide detectors. Smoke & CO detectors should be tested as soon as you move into the house and monthly. Replace smoke and CO detectors that are 10 years old. There should be a smoke detector in every sleeping room, outside of every sleeping room, and one every level of a house. CO detectors should be located within 10' of sleeping rooms.
